KOP 27  
Hwy 50 Robinson Summit

Figure 3.9-28

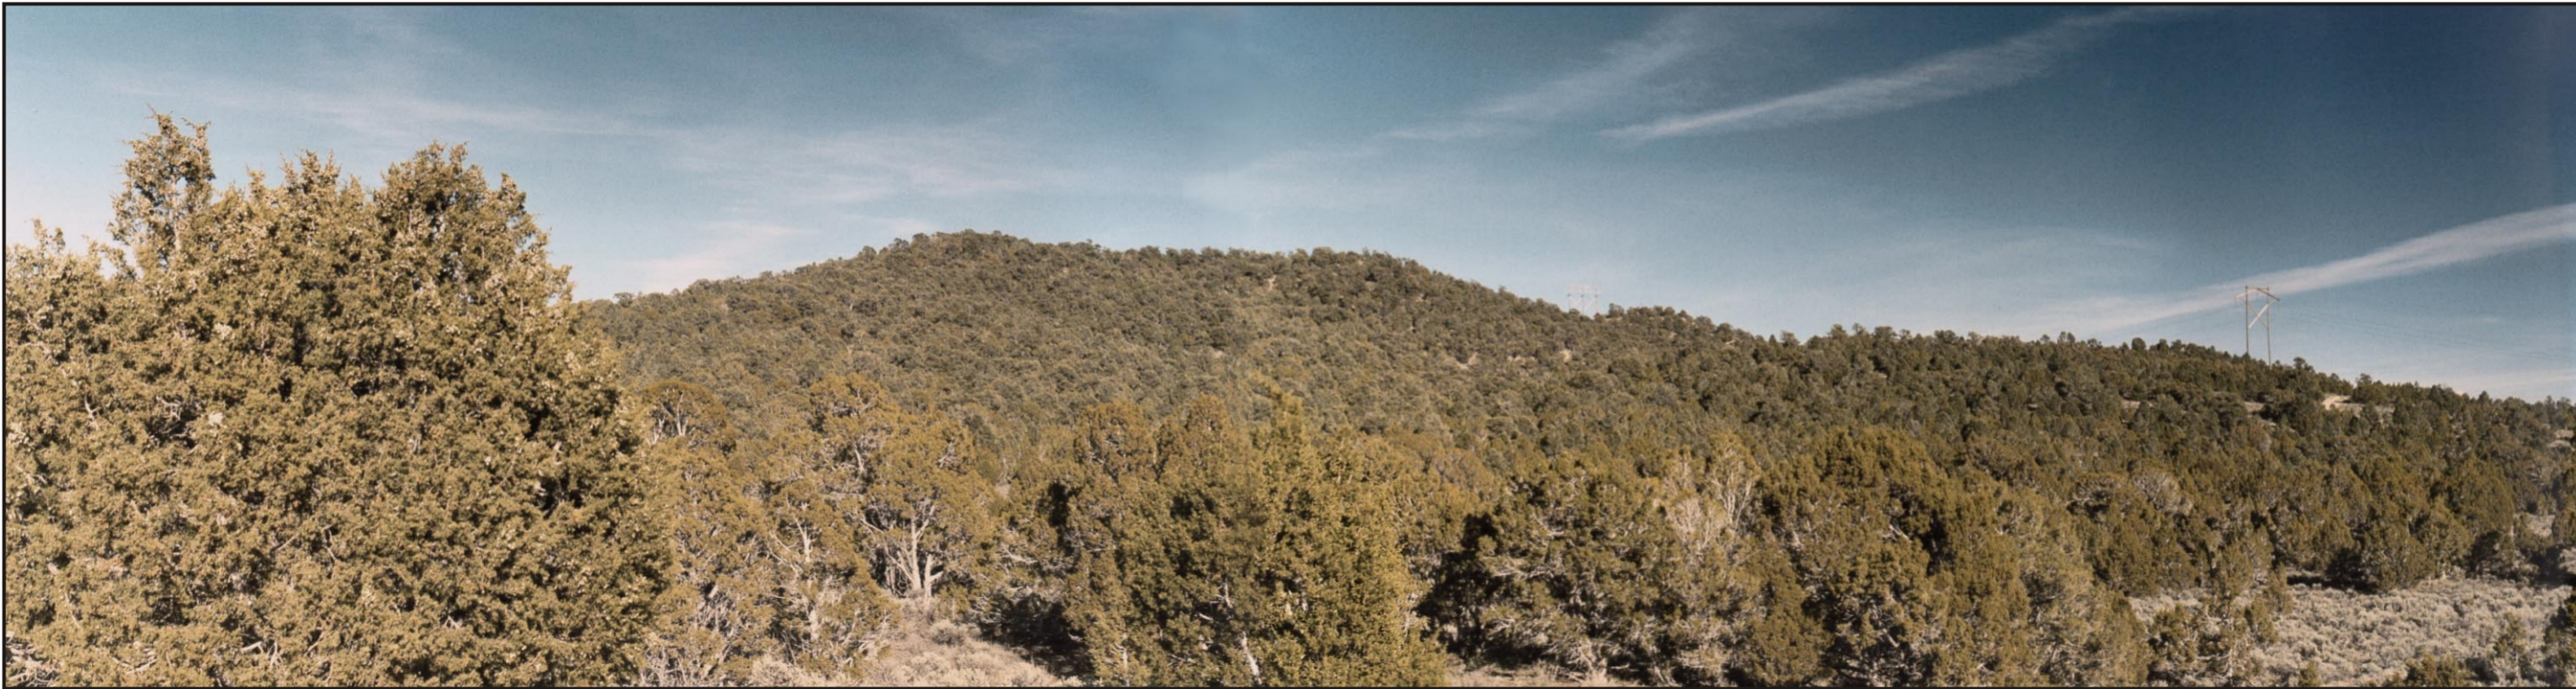
Existing Conditions

**Type/Sensitivity of Users:** Local and long distance travelers with a moderate interest in the visual quality of the area  
**Volume of Users:** High  
**T/L Distance from Viewer:** Middleground to foreground crossing views  
**T/L Prominence in Landscape:** Moderate to high - partially backdropped but some towers prominently skylined on nearby ridges  
**Existing Modifications:** Existing wood pole transmission line

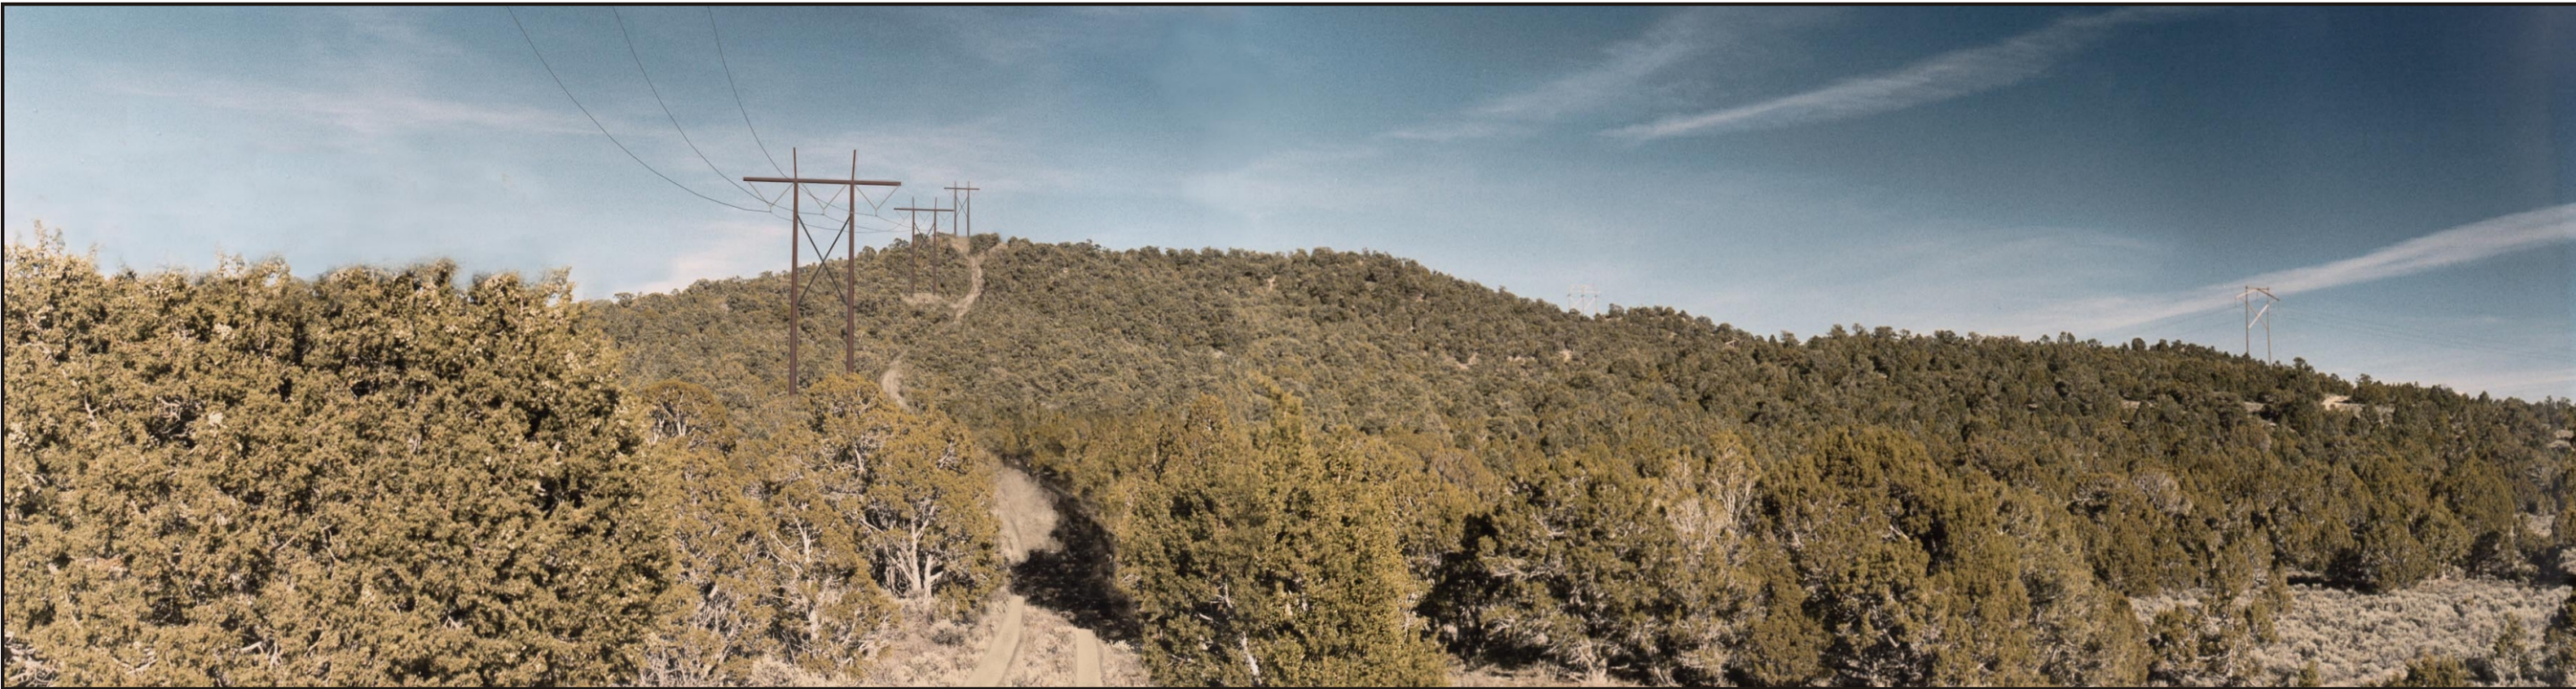
Future Conditions

Note: This alignment is located in a designated utility corridor.

**Contrast Rating:** Strong  
**VRM Class:** III (Interim)  
**Visual Impact Rating:** Medium
